Manhole Inspection Summary

Manhole # S07CC2018MH

Location Address: **6010 STEELE RD**

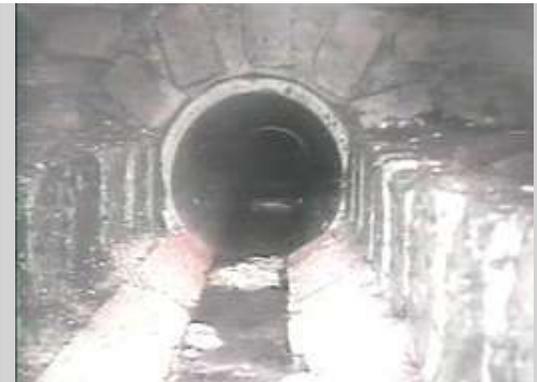
**8 in. Circular Gravity Sewer
Pipe In @ 6 O'Clock**

Rod and Bar (Angled)

Infiltration: **None** Pipe Seal Cond: **Sound**
